THE BUNDANON TRUST PROPERTIES  
HERITAGE MANAGEMENT PLAN • 2007

PREPARED BY PETER FREEMAN PTY LTD  
CONSERVATION ARCHITECTS + PLANNERS  
FOR THE BUNDANON TRUST AND DoCITA

VOLUME 2 OF 3  
THE BUNDANON CONSERVATION MANAGEMENT PLAN \* 1997

**BUNDANON  
CONSERVATION MANAGEMENT PLAN  
VOLUME 1  
CONSERVATION ANALYSIS**

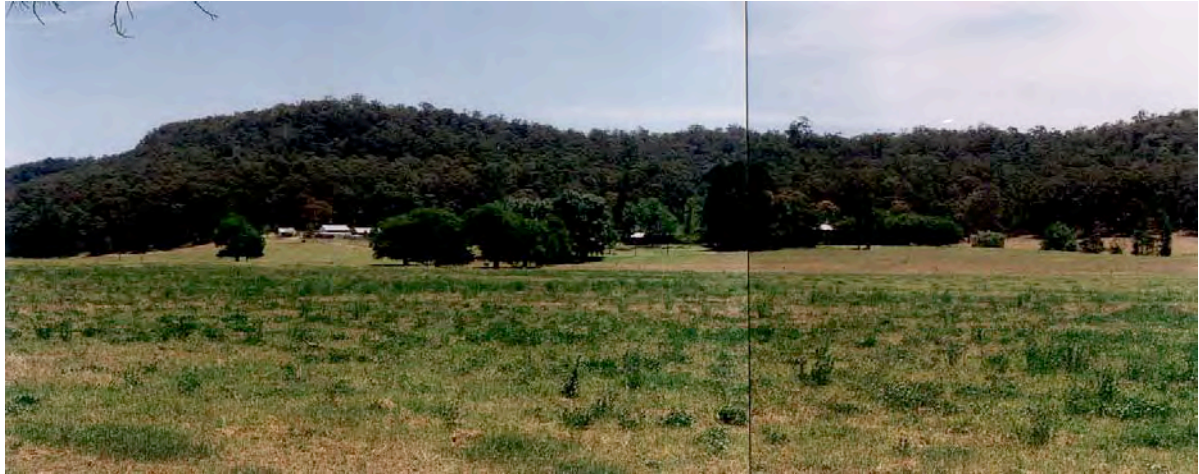
**Plate 1**

Cultural landscape of Bundanon from the south-east; towards the site of the former punt. Note coral trees in the foreground, and Bunyah pines signifying the location of Bundanon.

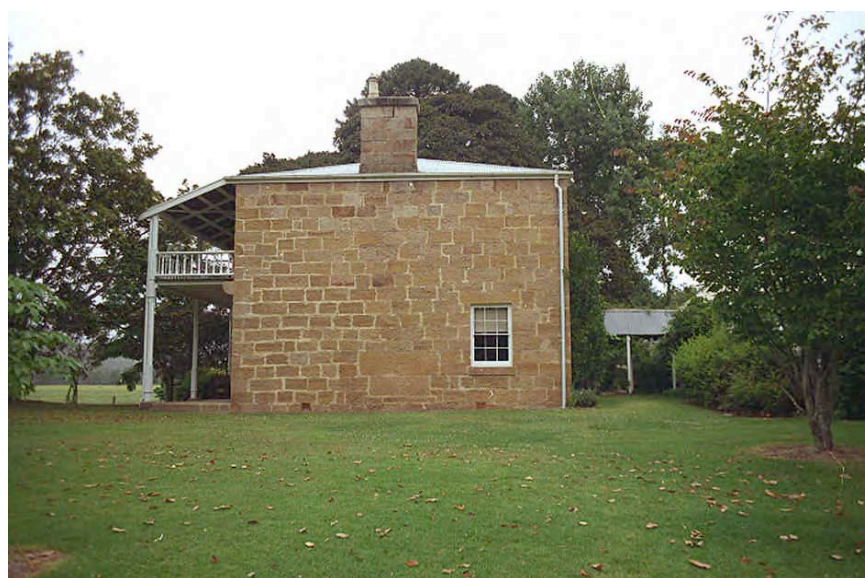
**Plate 7**  
North elevation of Bundanon  
**Source:**  
Peter Freeman Pty Ltd, 1997

The building originally featured panelled red cedar ceilings with planted mouldings covering the joints between individual 1-inch planks of variable width. Cedar panels were fixed with clenched Ewbanks patent nails in use until circa 1870. By 1975 the ceilings had been painted white presumably to match those in the new dining room and bathrooms. Floors were formed on hardwood joists; the ground floor featured butt jointed 6x1 inch hardwood

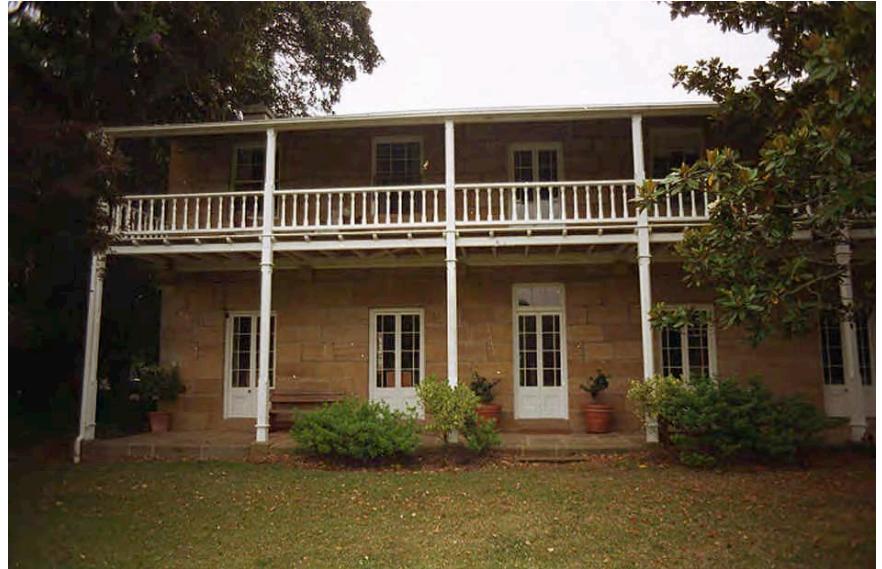
**Plate 10**  
Bundanon; ground floor terrace  
showing construction of verandah  
deck.  
**Source:**  
Peter Freeman Pty Ltd, 1997

The two-storey verandah is supported by six stop chamfered posts; at ground floor level these posts sit on simple sandstone bases which form part of the verandah surround. Sandstone paving slabs provide a hard wearing surface one step below the ground floor level. The first floor of the verandah is supported at the wall by six sandstone corbels. The verandah rafters are supported by the wall plate of the main roof, the lower ends supporting a fascia and gutter.

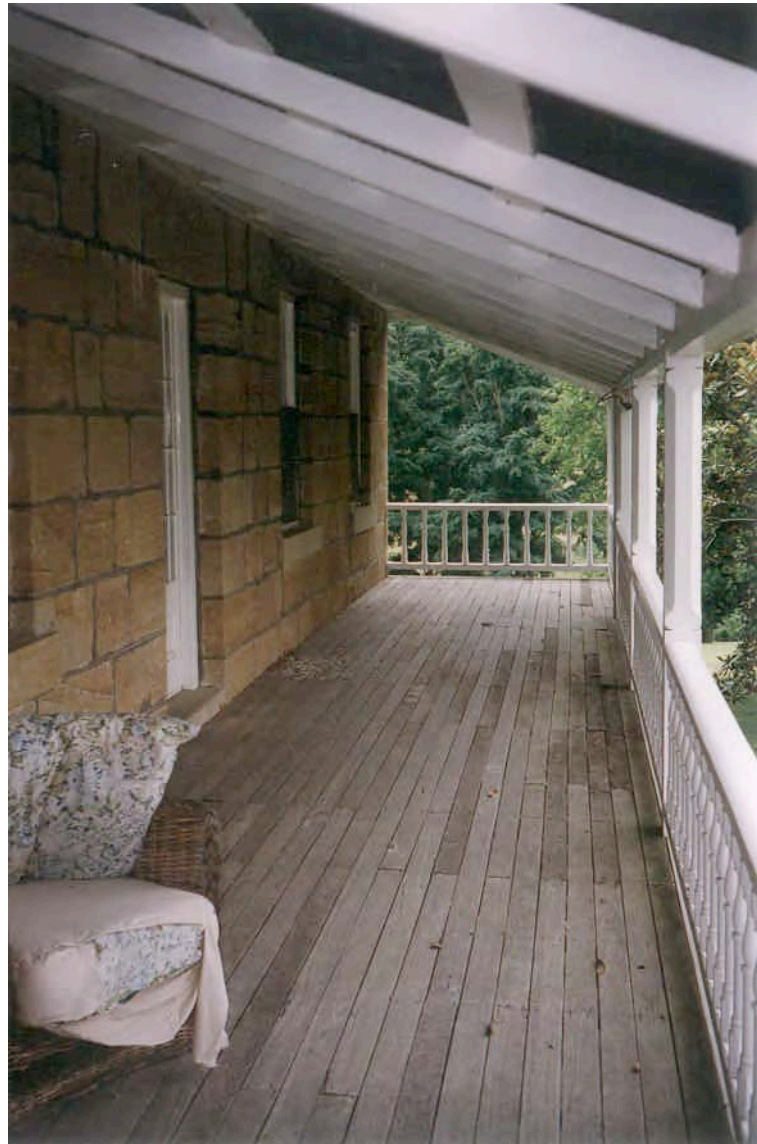
**Plate 11**  
Bundanon; upper verandah deck  
detail looking north.  
**Source:**  
Peter Freeman Pty Ltd, 1997

Lightweight diagonal bracing has been used at roof and first floor levels. Early photographs of the 1890s show the hipped roof as it is today covered with galvanised iron and contiguous with the two storey verandah. Internally the main roof is of lightly framed construction with wide battens of varying width supported on small section hardwood joists similar to those used in the other 19th century buildings roofed with corrugated iron. The roof was reconstructed under the supervision of Allen Jack & Cottier in the late 1960s. Two ashlar sandstone chimneys with simple cappings, one at each end of the building, complete the simple external symmetry of the building. The masonry of the northernmost chimney requires resetting if it is to remain in place.

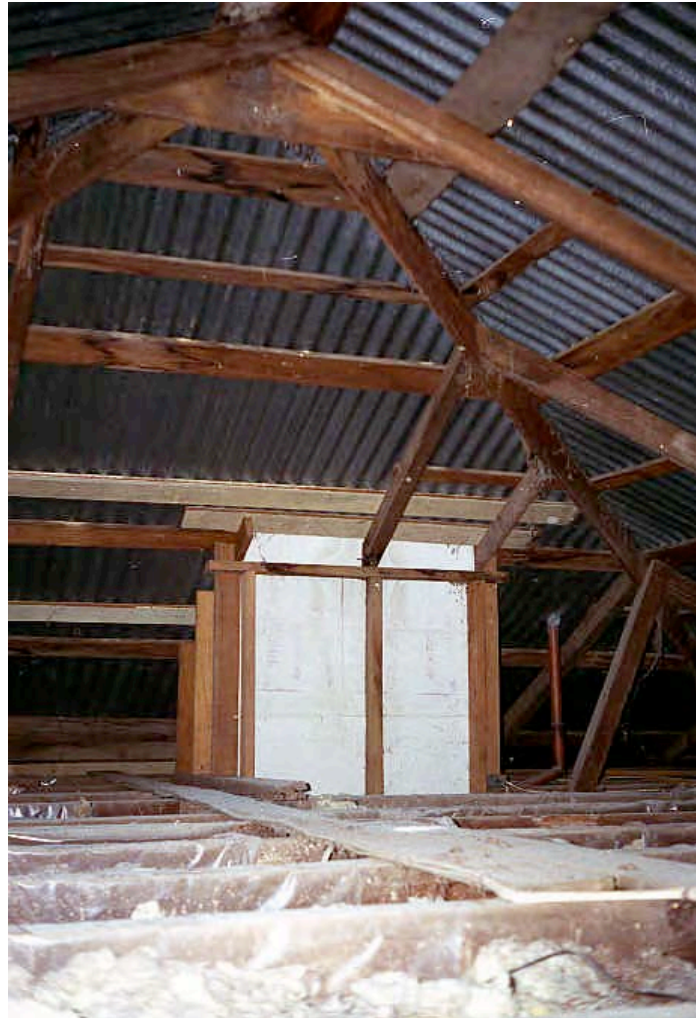
Plate 18  
Bundanon; hipped roof form  
reconstructed c.1968 with  
modified rafters and bearers.  
Source:  
Peter Freeman Pty Ltd, 1997

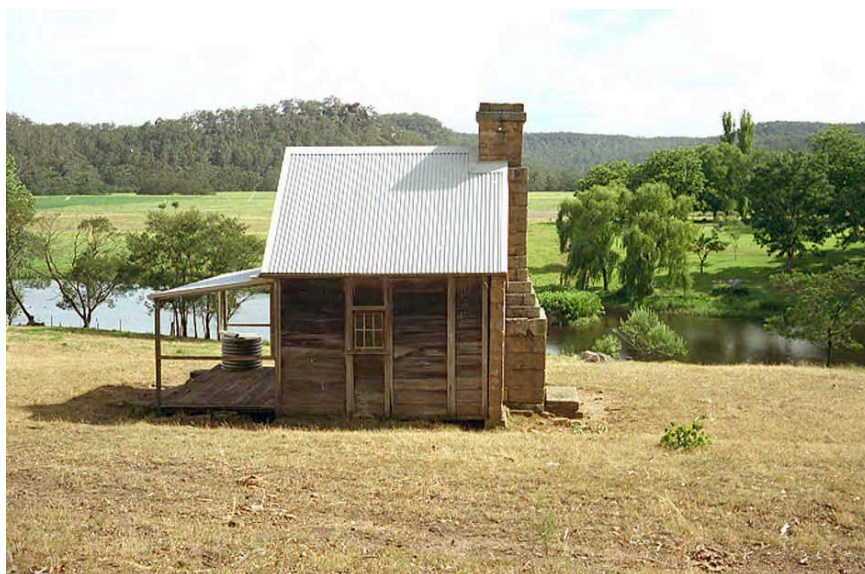
Plate 20  
Singleman's Hut from the north.  
Source:  
Peter Freeman Pty Ltd, 1997

Each side wall has three panels constructed of split and adzed drop slabs in a light weight stud frame held in place by nailed battens. One side wall has a single six-pane window the other two 6 pane sashes side by side of similar design; both windows are modern red cedar replacements. A simple skillion lean to verandah encloses the entrance wall. Four drop slab panels complete the wall below the weatherboards; a ledged door provides access to the hut.

The hut has been re-roofed with Colorbond sheeting although originally clad with galvanised iron sheet. The hut has been lined internally with Western Red Cedar and a small window inserted in the weatherboard gable. The single battened door has been reinforced internally to match the red cedar lining. A small ladder provides access to a loft occupying half the floor area. Due to the roof linings it was not possible to inspect the roof structure. New barge boards have been fitted to the sandstone gable wall.

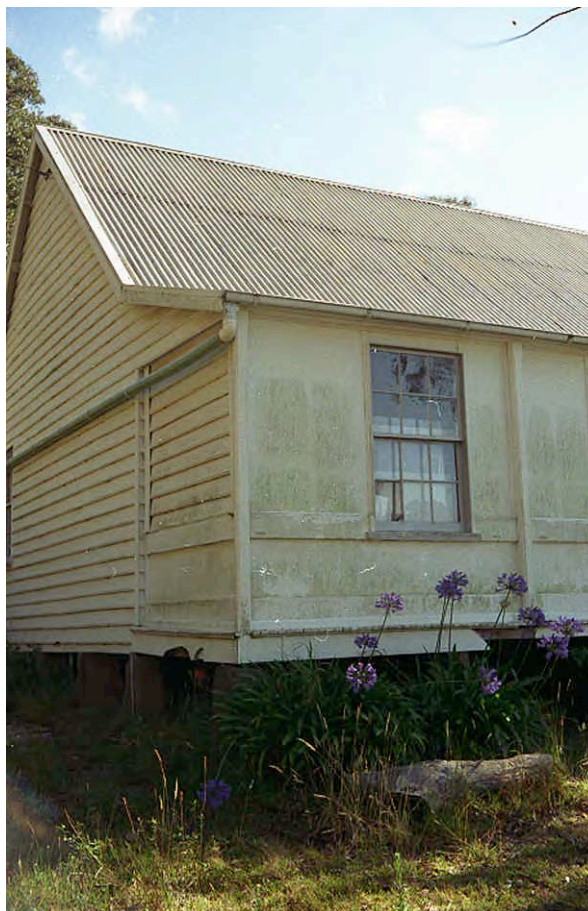
**Plate 23**

South-west corner of the Manager's Cottage, showing verandah infill and re-positioned 6x6 pane sash window effected in the 1970s.

Internally the building retains few of its original finishes with the exception of painted dressed and edge beaded tongue and groove Colonial Pine lining boards on the ceiling of the easternmost room (lined above in the roof space with newspapers of the early 1960s). Skirtings have been replaced by 19x42 mm maple scantlings and walls covered with a combination of fibre boards, tongue and groove radiata boards and plastic laminates. The 6x1 inch tongue and groove hardwood floor boards appear to be original. The internal walls were probably lined with tongue and groove Colonial Pine boards similar to those used in the remnant ceiling and in the later kitchen. Externally the walls of the original core structure are clad with dressed, edge beaded tongue and groove hardwood boards. The verandah form remains intact supported by 6 stop chamfered posts; two timber handrails define the central entrance and steps. The original entrance steps formed a single flight in traditional manner. In the McDonald and McGrath period of occupation the verandah appears to have been accessible only from inside

the building. This suggests that double railings and panels were installed in the verandah at this time.

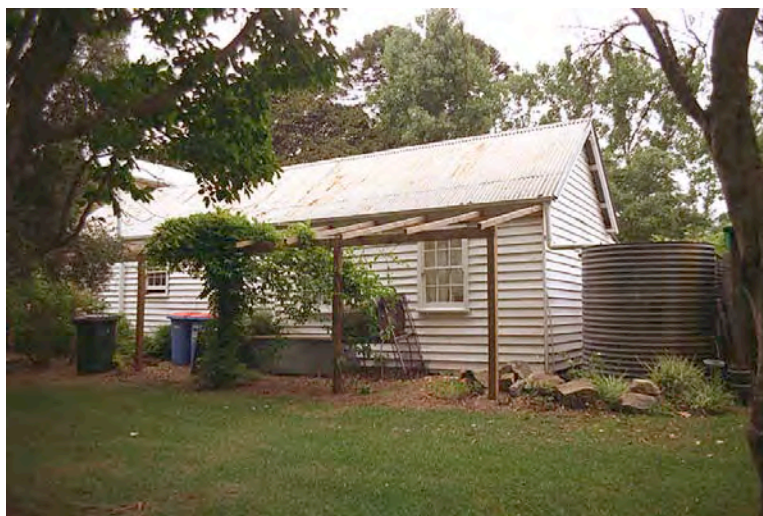
**Plate 24**  
Servants' Quarters from the north,  
with a modern pergola addition.  
**Source:**  
Peter Freeman Pty Ltd, 1997

The three room building and verandah were initially equipped with guttering and a large galvanised iron water tank in the area now occupied by the later brick in-ground cistern built to supply the 'new', separate kitchen. Two additional rooms of similar construction were added in the nineteenth century and the verandah extended. The two sections of the building are differentiated by the external gable details and breaks in the external cladding. The earlier section of the building features a flush narrow bargeboard at the gable; the later section features a slight overhang and expresses the wide roofing battens used to fix the corrugated iron. The latter detail was also employed in the slab barn and manager's cottage. During refurbishment in the late 1960s and early 1970s the verandah was remodelled and the supporting posts moved to better align with the adjacent kitchen verandah. A pergola was also added to the northern side of the building.

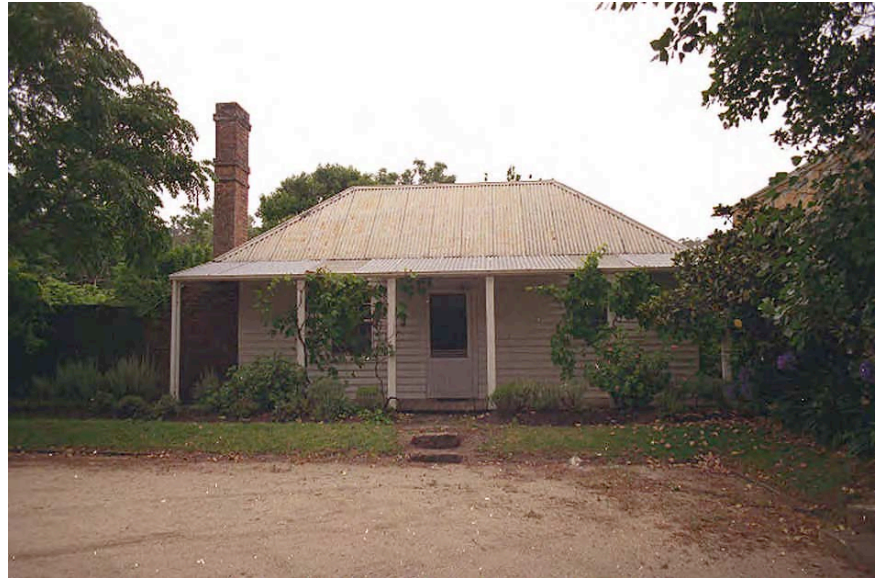
**Plate 25**  
1880s kitchen from the south-west.  
**Source:**  
Peter Freeman Pty Ltd, 1997

smaller Victorian Georgian cottage with its central door and symmetrically placed 6x6 pane sash windows. The 9.2x4.5 metre lightly framed stud building on sandstone footings was constructed of sawn hardwood clad internally with beaded tongue and groove pine boards and externally with dressed edge beaded hardwood weatherboards. The hipped roof is expressed internally in a coffered ceiling, fixed to collar ties and rafters, appropriate to its use as a kitchen. Four small section hardwood ties span the width of the building at wall height. The northern section of the building served as the servants dining room separated by a screen from the kitchen with its brick fireplace, cast iron range and oven. These functional areas are to some extent expressed in the quality and wear patterns of the 6x1 inch butt jointed hardwood flooring. The building appears to have been constructed with verandahs on both sides supported by stop chamfered posts.

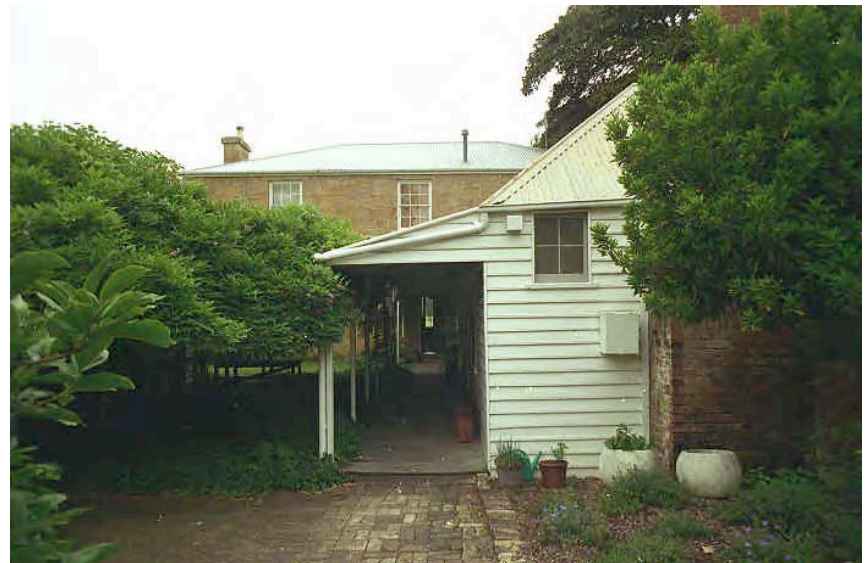
**Plate 26**  
1880's kitchen with external bread oven and flues. Note how the ground levels have risen, obscuring the foundations.  
**Source:**  
Peter Freeman Pty Ltd, 1997

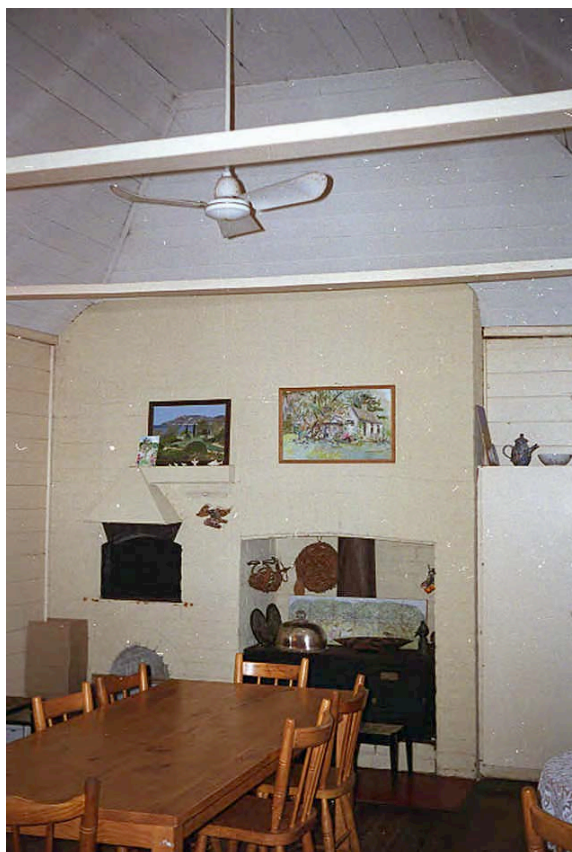
**Plate 28**  
1880's kitchen; north-east corner.  
A screen originally divided the  
building into two rooms.  
**Source:**  
Peter Freeman Pty Ltd, 1997

The building has minimal modifications remaining in use as the kitchen following demolition of the skillion kitchen and dedication of the main house to more aesthetic pursuits in the 1960s and 1970s. Changes include removal of the internal timber partition and the creation of a new verandah deck on the north side over an existing concrete verandah deck/footpath.

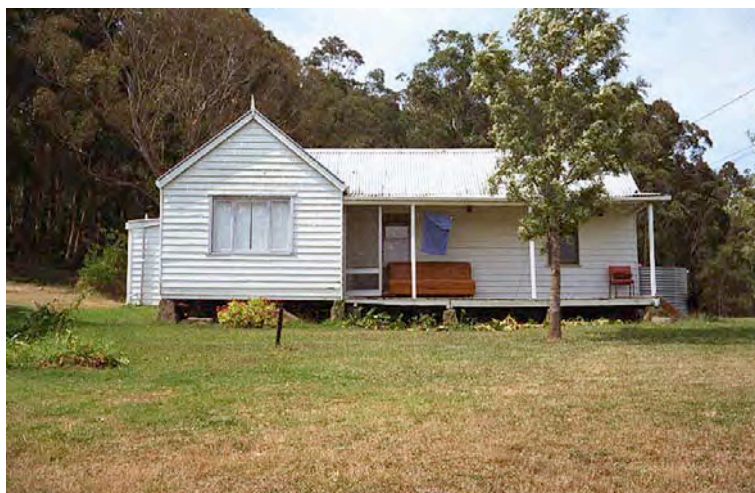
**Plate 30 (Bottom)**

Worker's Cottage 1, north facade. The gabled extension of 1946-49 is evident in its poor workmanship.

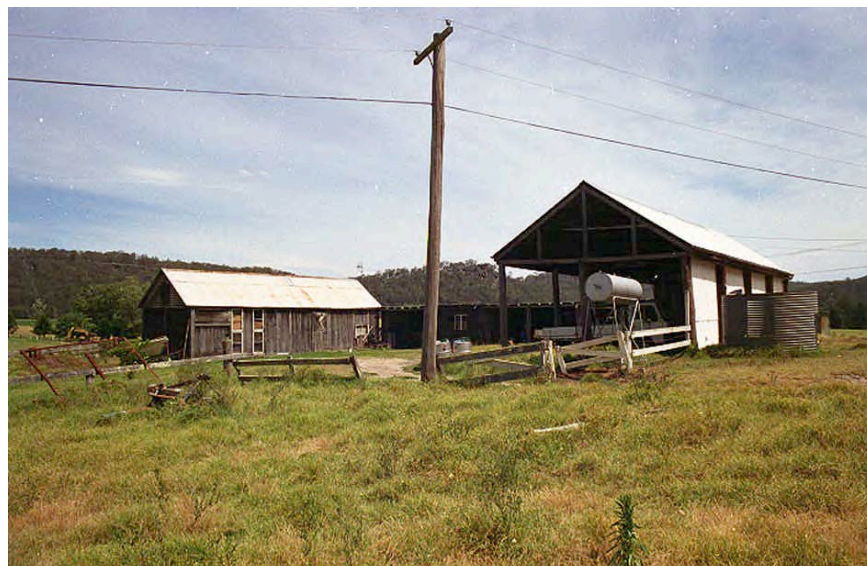
#### **Plate 31**

Slab timber barn from the north-west, in association with workshops and hay barn.

The extant slab barn at Bundanon featured all these characteristics originally although the barn appears to be a little lower than others of its kind. In common with other timber structures at Bundanon it is supported on large blocks made from roughly squared local sandstone. The 5.5x15.5 metre building was constructed of a mixture of local sawn hardwood and split slabs inserted into a sawn timber frame below a galvanised iron roof. The frame consists of sawn top and bottom plates with square corner and intermediate posts defining the door openings. Intermediate rectangular posts define the functional areas of each 3 metre high side wall. The gable walls are infilled with split drop slabs [either side of a central post with diagonal braces] which also infills the first bay at both ends of each side wall. The drop slabs sit in grooves formed by nailing battens to the vertical frame members; the nails used appear to be the ubiquitous machine made wire-cut form which appeared on the market c.1870 and dominated it by the 1890s. The north west corner of the building retains a wall hatch [visible in early photographs] above vertical split slabs which reflect the vertical sawn slabs used elsewhere in the walls of the building.

The slab barn retains a considerable proportion of the original fabric. This includes the roof and gables, wall framing, drop slab wall cladding and the floor and foundation blocks. There has been some adaptation and replacement of fabric. The central main doors have been replaced with recycled and smaller stable type doors on the western side. On the eastern side the main doors have been lost and a number of vertical glazing panels inserted.

The slab barn, in common with other buildings of its type and age, has some settlement. The foundation blocks have been supplemented with Besser blocks in places. However the floor is in reasonable condition with boards partly replaced. The roof is in good condition and has effectively ensured that the building's frame has survived intact. The wall bottom plates and drop slab wall sections are in poor condition in particular at the exposed southern end. The condition of the building has been compromised by poor twentieth century modifications which have probably reduced the weather tightness of the walls. New diagonal ties have been used to stabilise the centre of the building. Termite damage is visible in the wall slabs at the north-east corner of the building. The latter may also have infected the floor.

***Condition***  
Poor

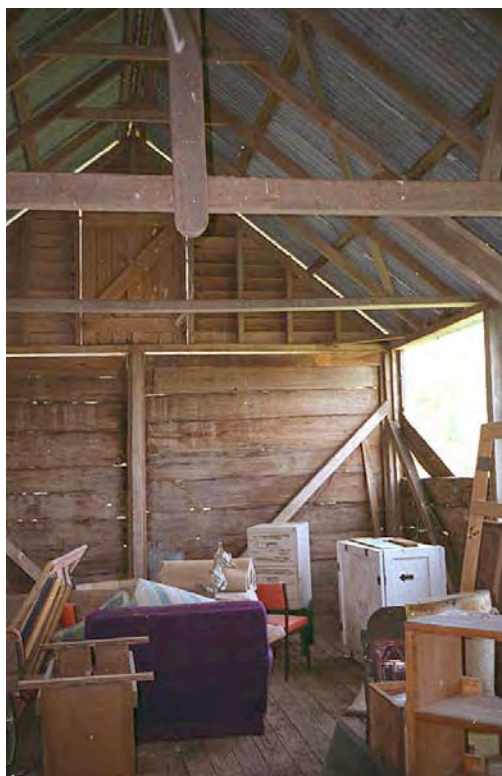
Plate 33  
Slab timber barn interior at the  
north-east gable.  
Source:  
Peter Freeman Pty Ltd, 1997

The roof is of relatively lightweight construction compared to the walls and floor and overhangs characteristically at each gable expressing the wide roofing battens. The gables are clad with weatherboard which defines the two loft doors, one at each end of the building. Although loft doors can imply a loft floor there is no evidence of a floor. The roof structure appears to have been designed to take only the load of the roof sheeting since it is supported by two lightweight trusses at the centre. The loft doors may have simply been used to help fill the barn to its limit. The floor is of sawn hardwood similar to the vertical sawn slabs used in the walls. Butt jointed planks span the length of the building and are supported and nailed to sawn hardwood joists.

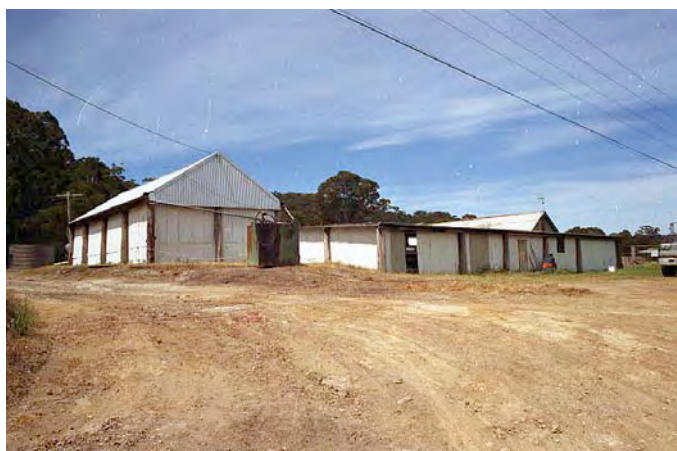
Plate 34 (Top)  
Hay barn, workshops and slab timber barn (at rear) from the south-west.  
Source:  
Peter Freeman Pty Ltd, 1997

The contemporary stockyards and cattle chute remain in use as part of ongoing farm operations but the workshop and barn are not in full use. All structures receive limited maintenance which is beginning to impact on their condition.

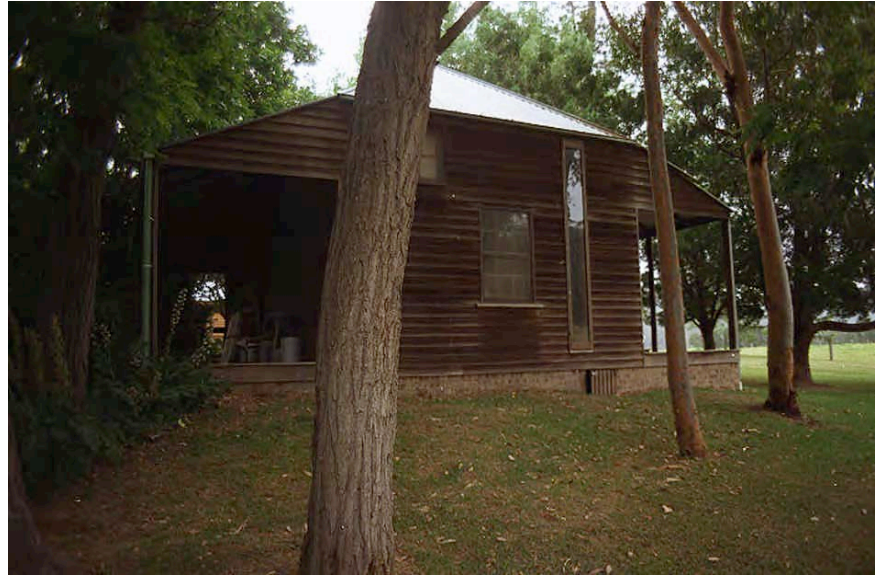
**Plate 36 (Top)**  
Arthur Boyd's studio from the north-east.  
**Source:**  
Peter Freeman Pty Ltd, 1997

A small modern weatherboard structure which interprets nineteenth century vernacular idiom in an effective manner. Brick foundations, stained weatherboards and a galvanised iron hipped roof create a building of simple proportions with skillion verandahs to back and front.

Windows are a combination of fixed lights and traditional 6x6 overhung sash types. The building remains in use as a studio under the Bundanon Trust.

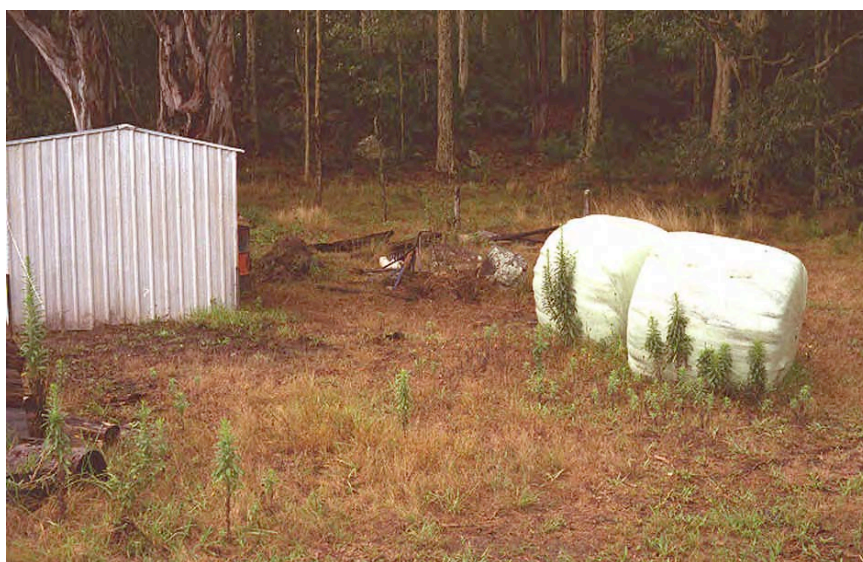
Plate 38  
Colgro and Calligan's humpy site,  
from the south-east.  
Source:  
Peter Freeman Pty Ltd, 1997

The site can be clearly located a short distance north of Worker's Cottage 1 from Clive Emery's anecdotal evidence. Little appears to remain on surface; the fire scar left by burning demolished buildings and clearing the area is still visible although no posts have been located. The exact location of the burials must be determined. Interpretive potential

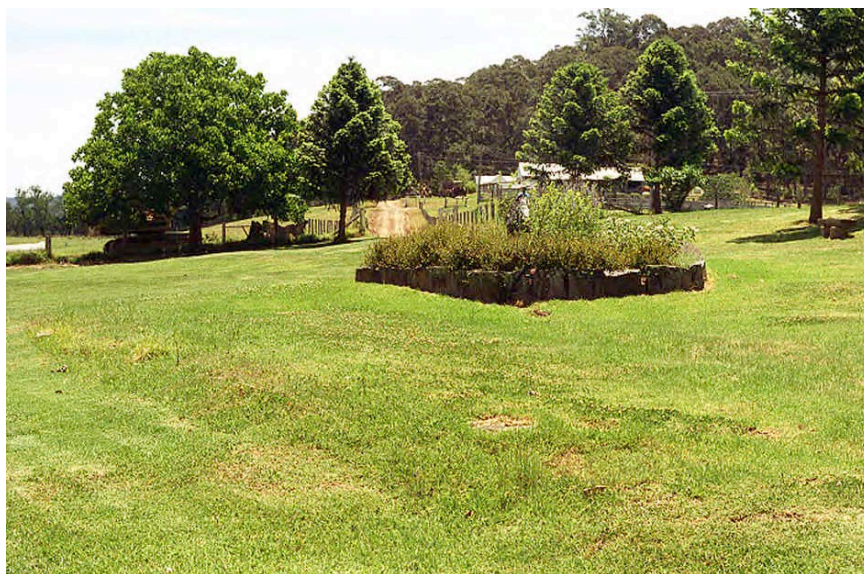
**Plate 39**  
Feedstalls and dairy foundations.  
**Source:**  
Peter Freeman Pty Ltd, 1997

Substantial stone paving visible on surface south of the main house. Upper surfaces of the paving impregnated with tar or bitumen similar to the foundation blocks at the former homestead site. Considerable potential for mapping the layout of the feedstalls and dairy/bails complex.

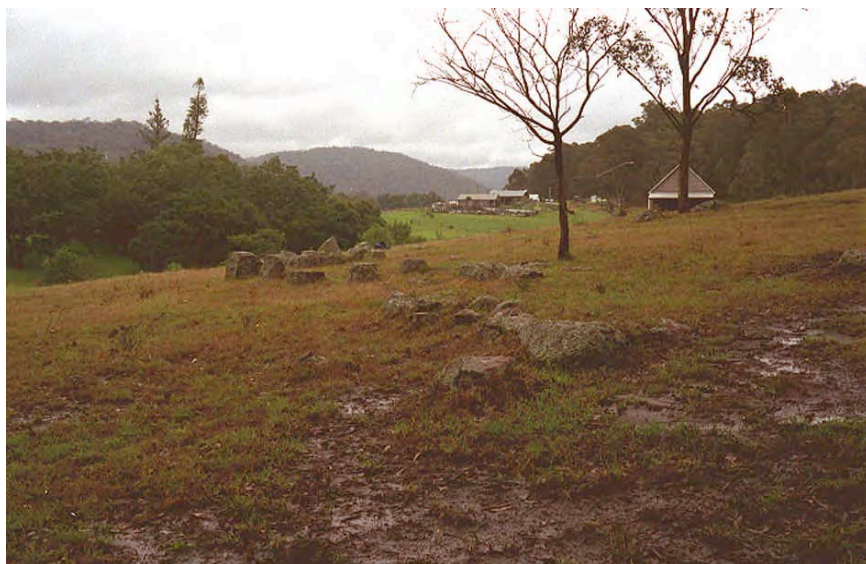
The substantial foundation blocks and collapsed rubblestone chimney and fireplace remain in situ from a raised timber hut some 6x3 metres in area. To the east, and almost contiguous with the hut site, a terraced area supported by a rough stone retaining wall indicates the site of a smaller hut or store. Both structures are characteristically sited along the contours. Construction details and materials are similar to the buildings at the former homestead site; the former hut site may date to c.1840.

Hut site c.1840. Stone foundations and piers for a small hut, with a fireplace and a separate store or shed with earthen floor (nearest).

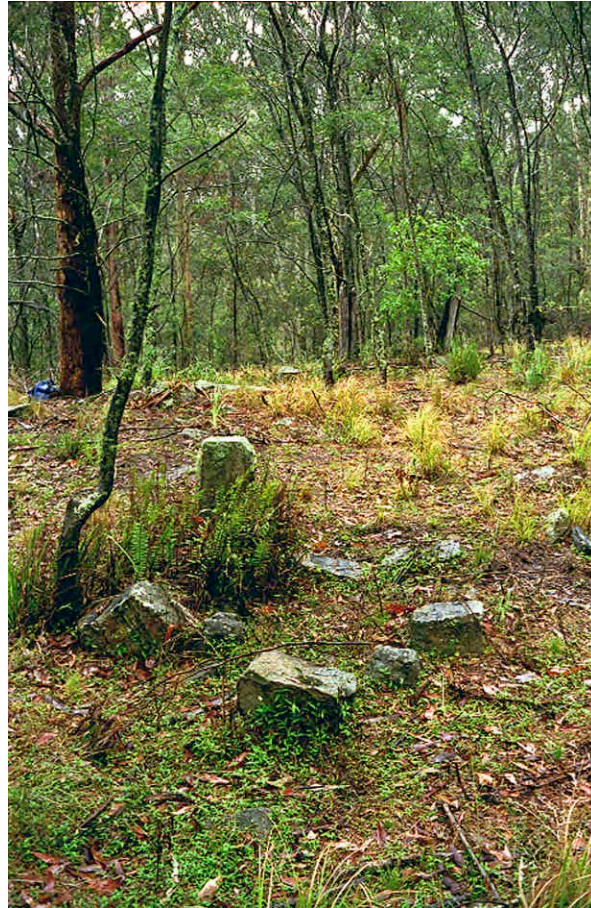
**Plate 41**  
First homestead site; western hut  
with foundation in foreground  
and chimney base visible at rear.  
View from the east.  
**Source:**  
Peter Freeman Pty Ltd, 1997

A view of the site c.1903 taken from Pulpit Rock indicates the existence of two gabled structures above the small lagoon or dam east of the main house towards Haunted Point. To the east of these structures the photographic image also suggests a third building with a hipped roof and substantial chimneys typical of small symmetrical Colonial Georgian timber cottages. A central door and flanking windows are clearly visible. The evidence on site matches this pattern closely. The westernmost two structures identified measured approximately 8x4 metres and 10x4 metres in area. Only the westernmost of these two structures retains evidence of its stone fireplace and chimney. Although the foundations appear to have been quarried in part for other structures (Worker's Cottage 1 perhaps) sufficient material remains to interpret the site.

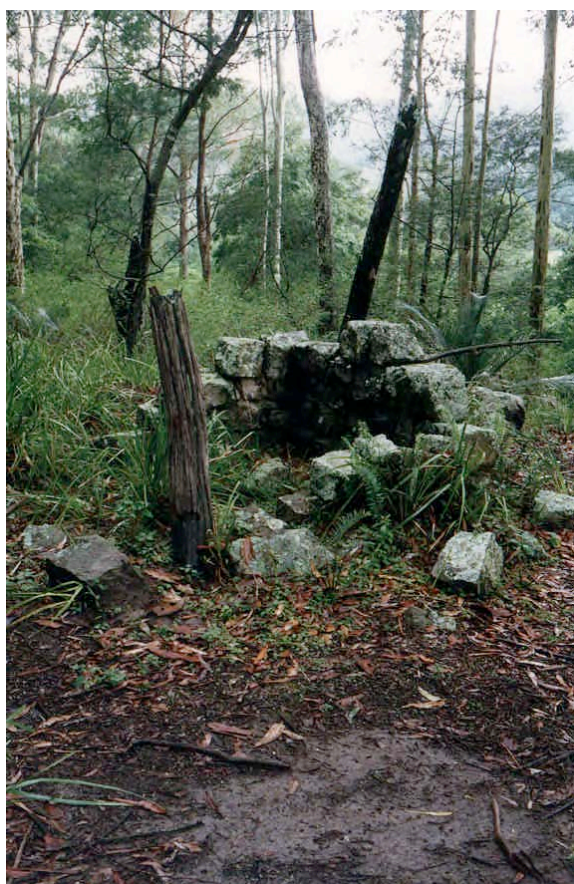
**Plate 43**

Twenty metres to the east of these two structures the remains of a substantial stone fireplace and chimney indicate the location of a third structure in approximately the location of that in the photographic evidence. Both fireplaces have been reinforced with earth-bound timber posts which remain in place, partly burnt. The use of shell based lime mortar supports their construction as permanent structures. The easternmost fireplace is of roughly squared rubblestone masonry, and measures two metres wide by 1.5 metres deep, suggesting that the room extended north from the fireplace. This orientation does not however appear to accord with the photographic evidence.

First homestead site. Easternmost fireplace and chimney base with external timber supports. View from the north-west.

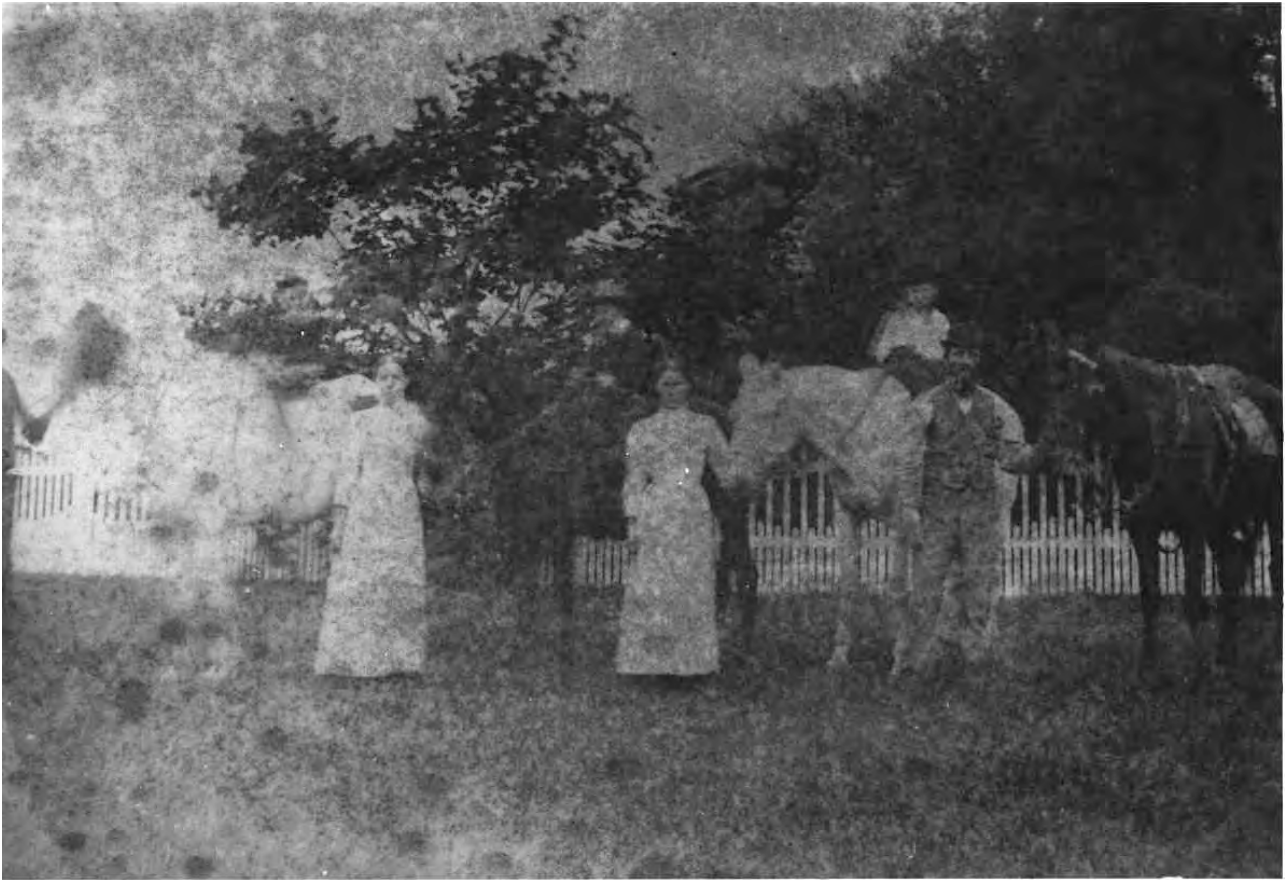
**BUNDANON  
CONSERVATION MANAGEMENT PLAN  
ILLUSTRATED CHRONOLOGY • FIGURE 2**

Hugh McKenzie [?] and family at Bundanon, c1890s  
Photograph taken from the east.

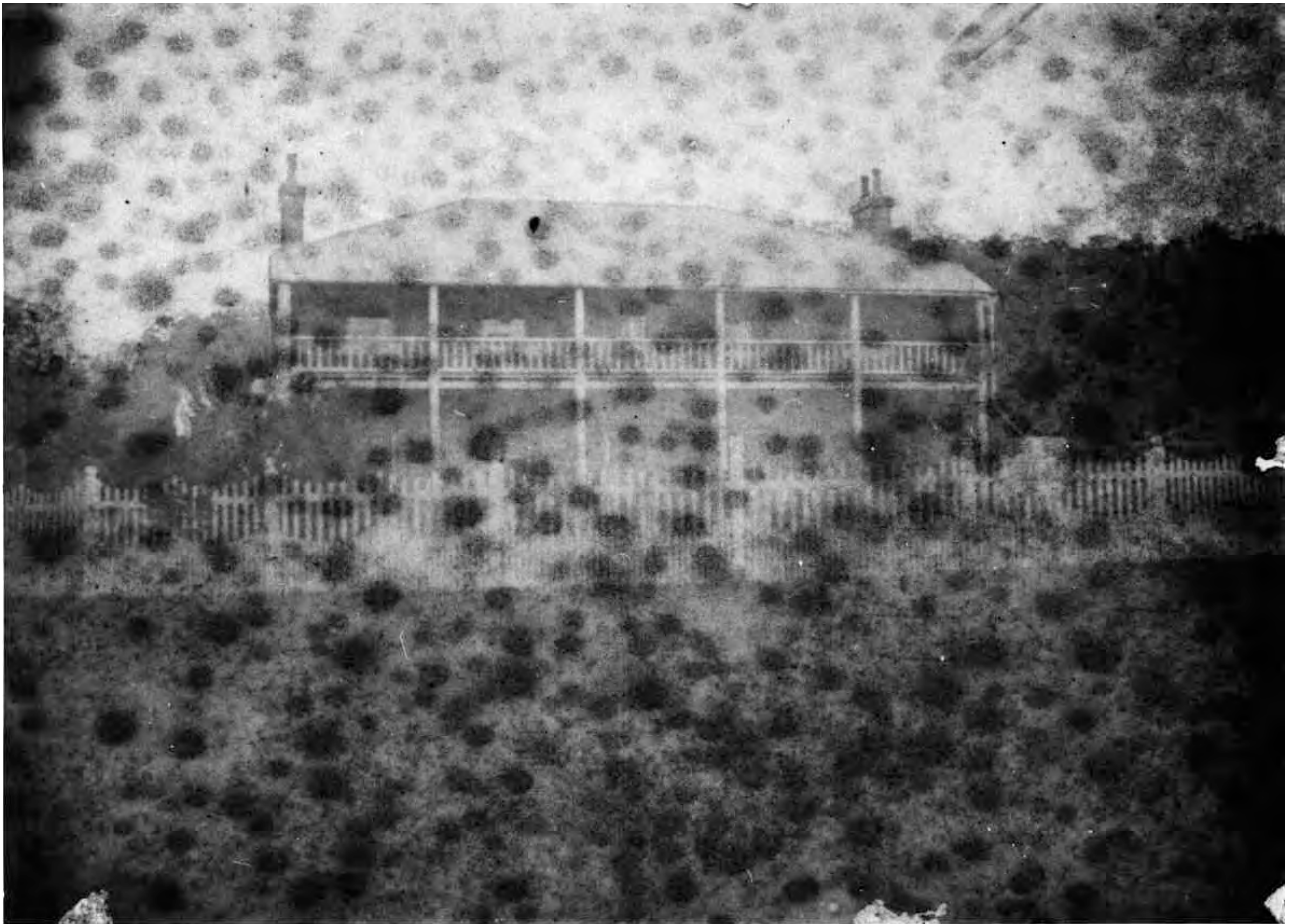
**BUNDANON  
CONSERVATION MANAGEMENT PLAN  
ILLUSTRATED CHRONOLOGY • FIGURE 4**

Bundanon house from the east, c1890s

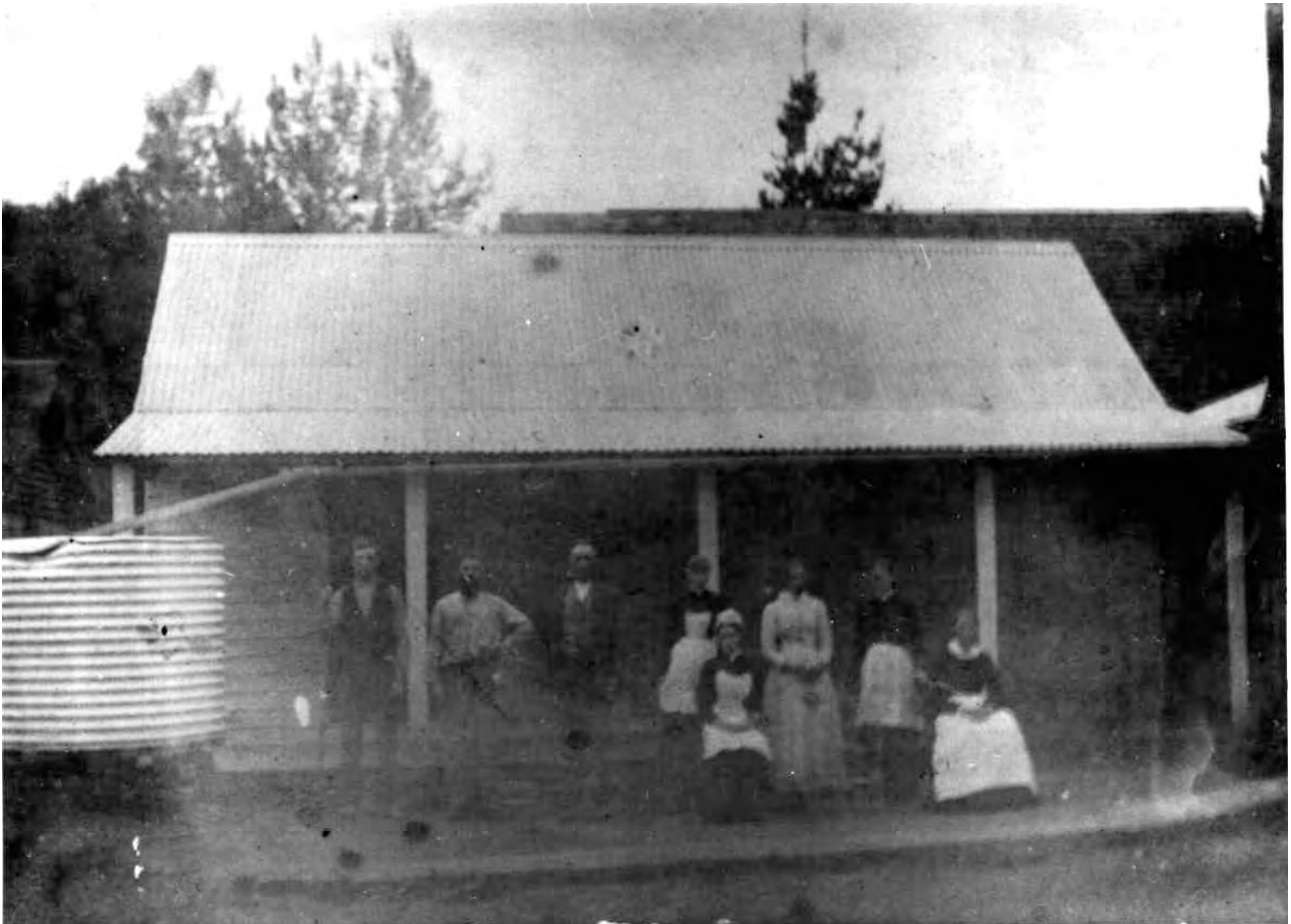
**BUNDANON  
CONSERVATION MANAGEMENT PLAN  
ILLUSTRATED CHRONOLOGY • FIGURE 5**

Maids and farmhands outside the servants' quarters at Bundanon, c1890. Note the shingle roofed shed behind, the pine tree denoting a track and, to the right, the chimney edge and skillion roof of the original kitchen on the western side of the main house.

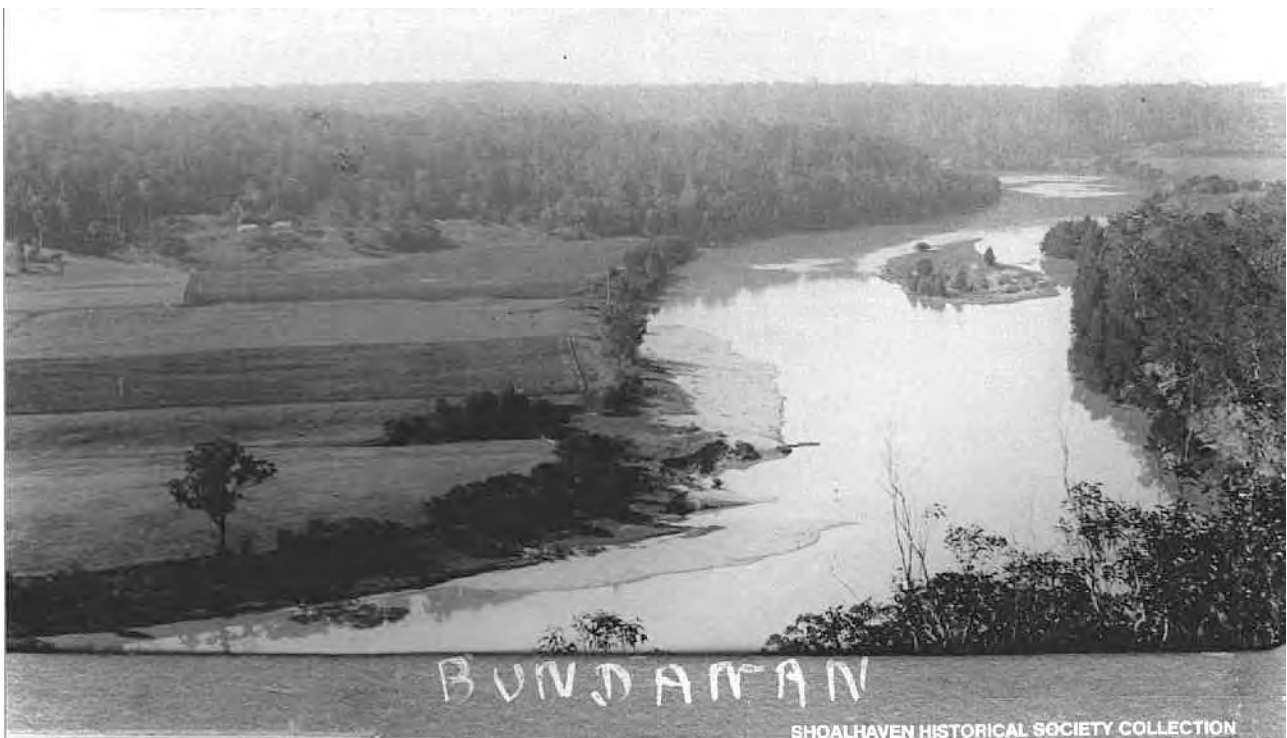
**BUNDANON  
CONSERVATION MANAGEMENT PLAN  
ILLUSTRATED CHRONOLOGY • FIGURE 6**

Bundanan [sic], the first homestead site, from Pulpit Rock, c1903.  
The three homestead buildings appearing in this photograph were  
destroyed by fire before the mid 1920s. Note the extent of clearing behind  
the first homestead site left of centre.

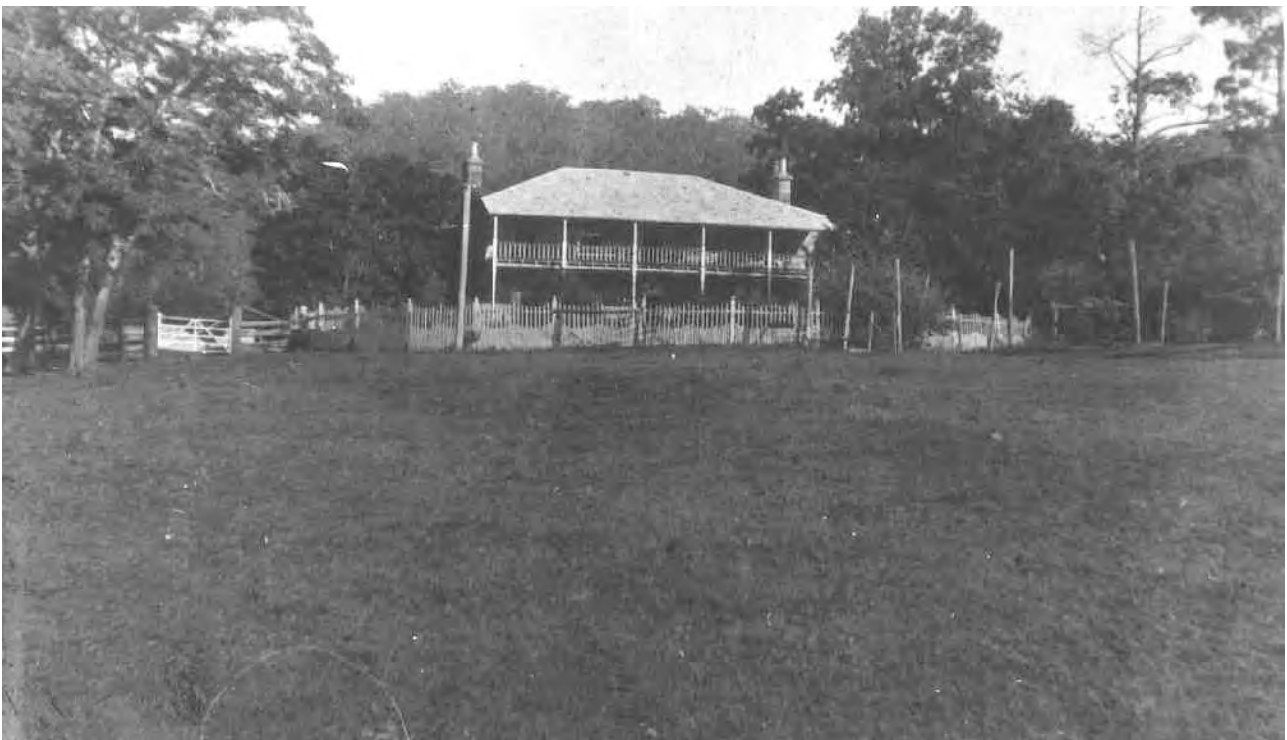
**BUNDANON  
CONSERVATION MANAGEMENT PLAN  
ILLUSTRATED CHRONOLOGY • FIGURE 12**

Bundanon house from the SE, 1918. Note the extensive Moreton Bay fig and semi-circular decorative picket fence. The tennis court appears to be in dis-use at this time.

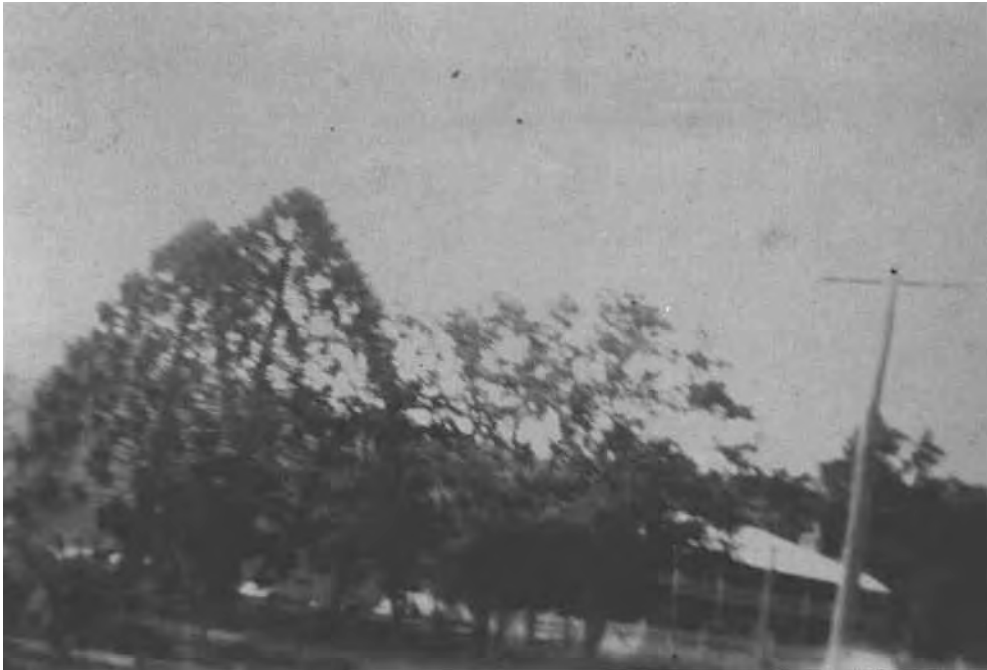
**BUNDANON  
CONSERVATION MANAGEMENT PLAN  
ILLUSTRATED CHRONOLOGY • FIGURE 37**

The Henry family on the 'Common' at Bundanon, **late 1920s**. Note the small tank and stand adjacent to the skillion kitchen; this may have served the modest bathroom located at the southern end of the skillion. A small window in the end of the skillion appears to have provided light and ventilation.

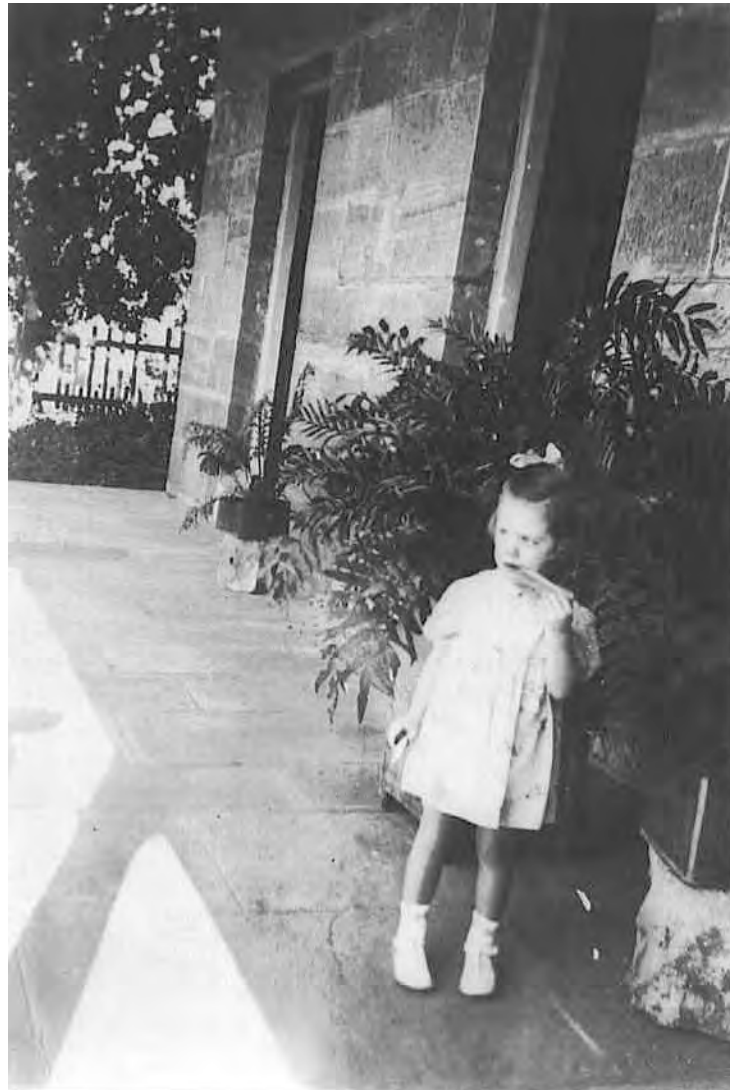
**BUNDANON  
CONSERVATION MANAGEMENT PLAN  
ILLUSTRATED CHRONOLOGY • FIGURE 46**

Annette Martin, aged two-and-a-half, **1944**. Note that the enclosing picket fence has remained intact, as well as the side gate to the Common. Note also that the paintwork and the garden are in poor condition.
