THE BUNDANON TRUST PROPERTIES  
HERITAGE MANAGEMENT PLAN • 2007

PREPARED BY PETER FREEMAN PTY LTD  
CONSERVATION ARCHITECTS + PLANNERS  
FOR THE BUNDANON TRUST AND DoCITA

VOLUME 2 OF 3  
THE BUNDANON CONSERVATION MANAGEMENT PLAN \* 1997

**BUNDANON  
CONSERVATION MANAGEMENT PLAN  
VOLUME 1  
CONSERVATION ANALYSIS**

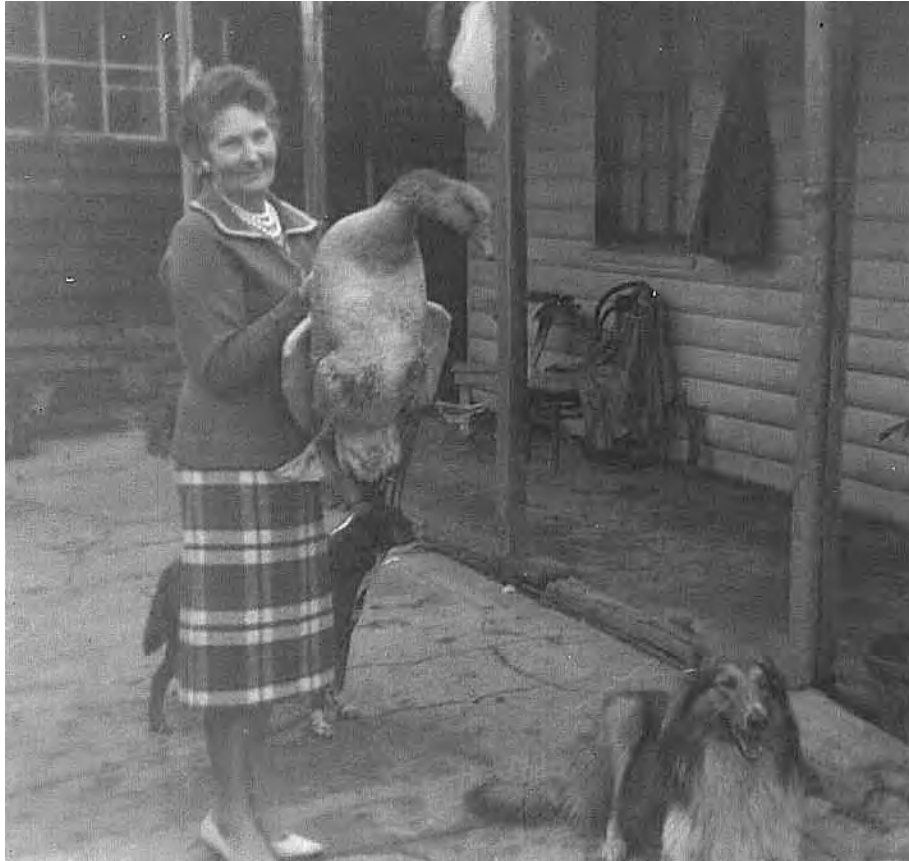
**BUNDANON  
CONSERVATION MANAGEMENT PLAN  
ILLUSTRATED CHRONOLOGY • FIGURE 49**

Lorna and Harry Warren in the courtyard between the servants' quarters and the late 19th century weatherboard kitchen, **1960**. The massive sandstone masonry of the early kitchen chimney dominates the space. Note the similarity of the weatherboard skillion to the servants quarters and the finely detailed six-pane window. The entrance doorway to the skillion was immediately right of the picture. Ground levels were already rising due to the raised pavement and the raised garden bed against the chimney.

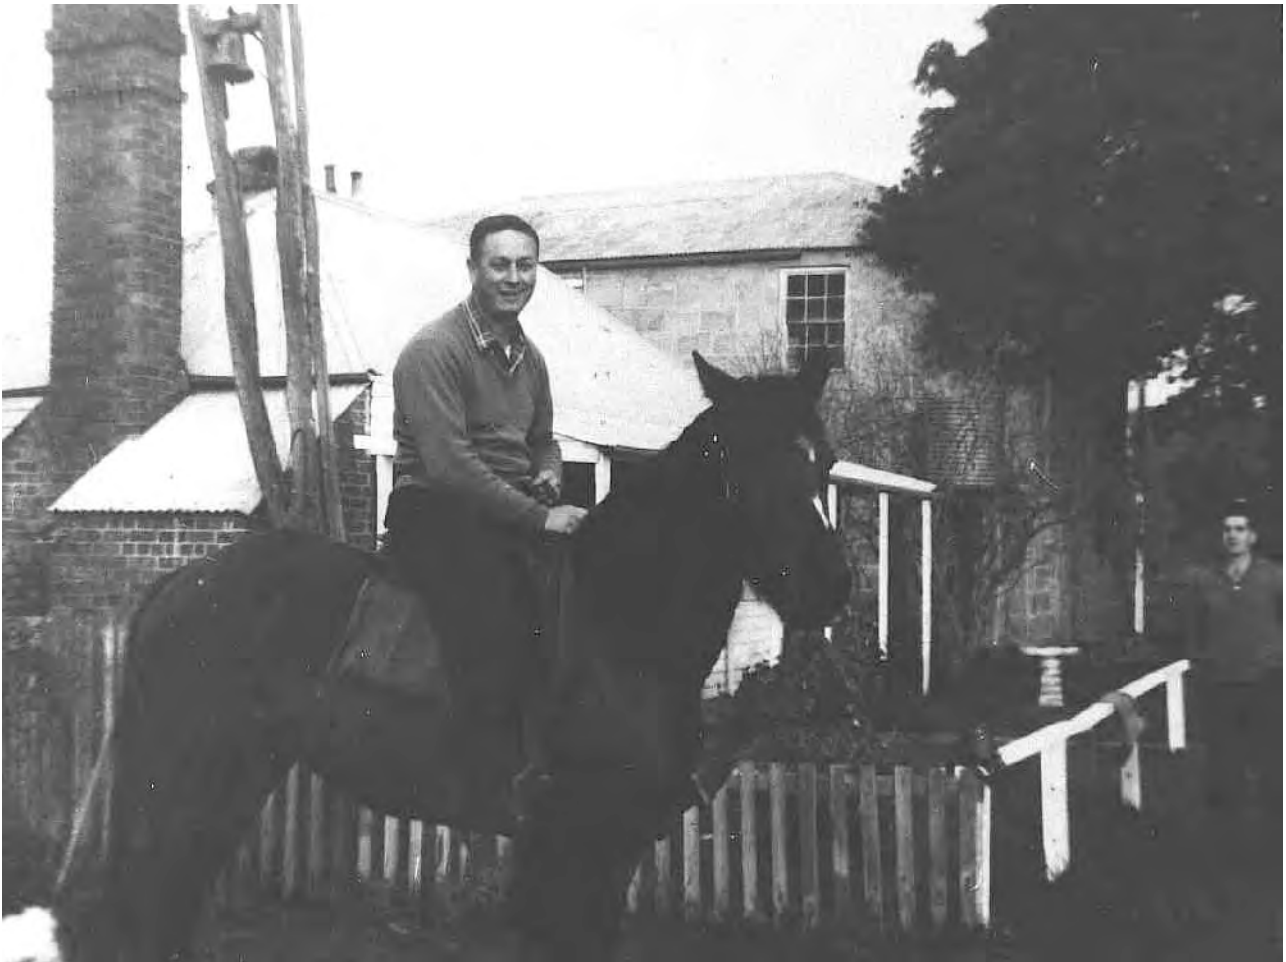
**BUNDANON  
CONSERVATION MANAGEMENT PLAN  
ILLUSTRATED CHRONOLOGY • FIGURE 70**

Horsewoman [not identified] with the hipped roof kitchen building in the background. ND but **1960s**. Note the poor condition of the weatherboards and the gates and gutters, which suggest some degree of decay. The homestead bell and its support remains in place.

Horseman [not identified] in front of the main house and hipped roof kitchen at Bundanon in the early 1960s. Note the fenced garden to the kitchen [in contrast to the previous photograph, Figure 69]. The guttering to the main house is in poor repair or missing altogether, suggesting that little maintenance took place during the McKenzie family's ownership at this time.

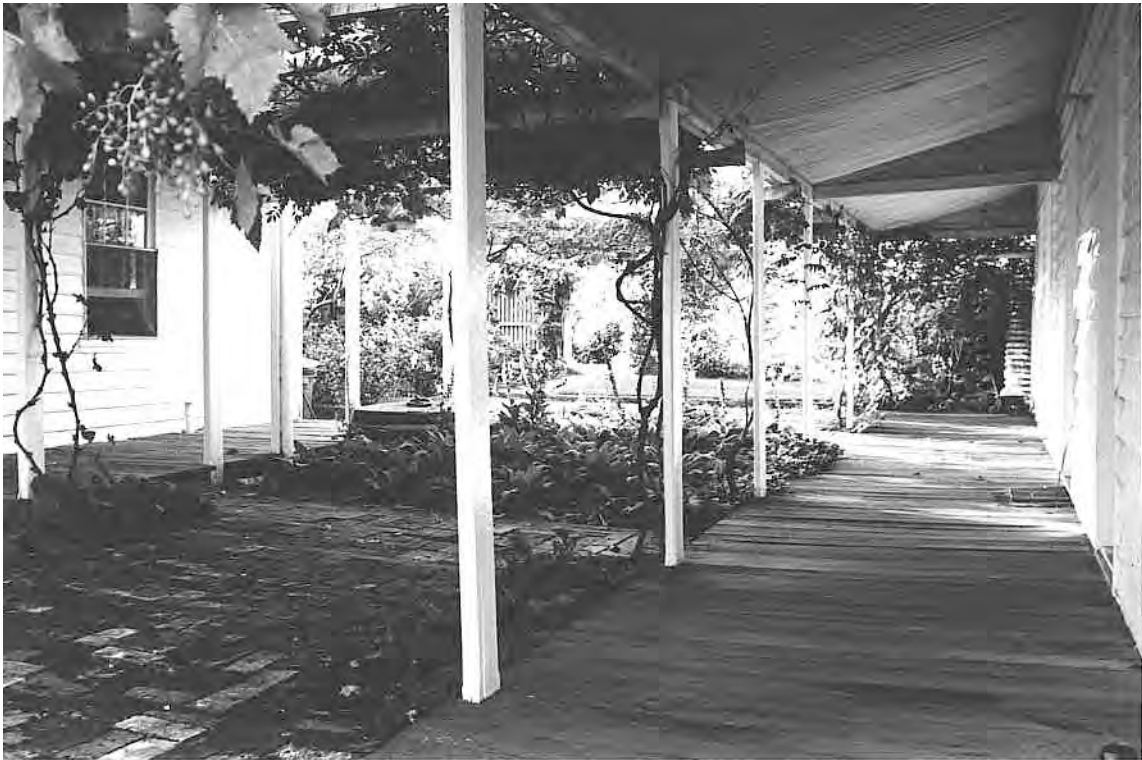
**BUNDANON  
CONSERVATION MANAGEMENT PLAN  
ILLUSTRATED CHRONOLOGY • FIGURE 74**

The area between the servants' quarters and the kitchen, with new landscaping introduced by the McGrath and MacDonald partnership, ND but c1972.

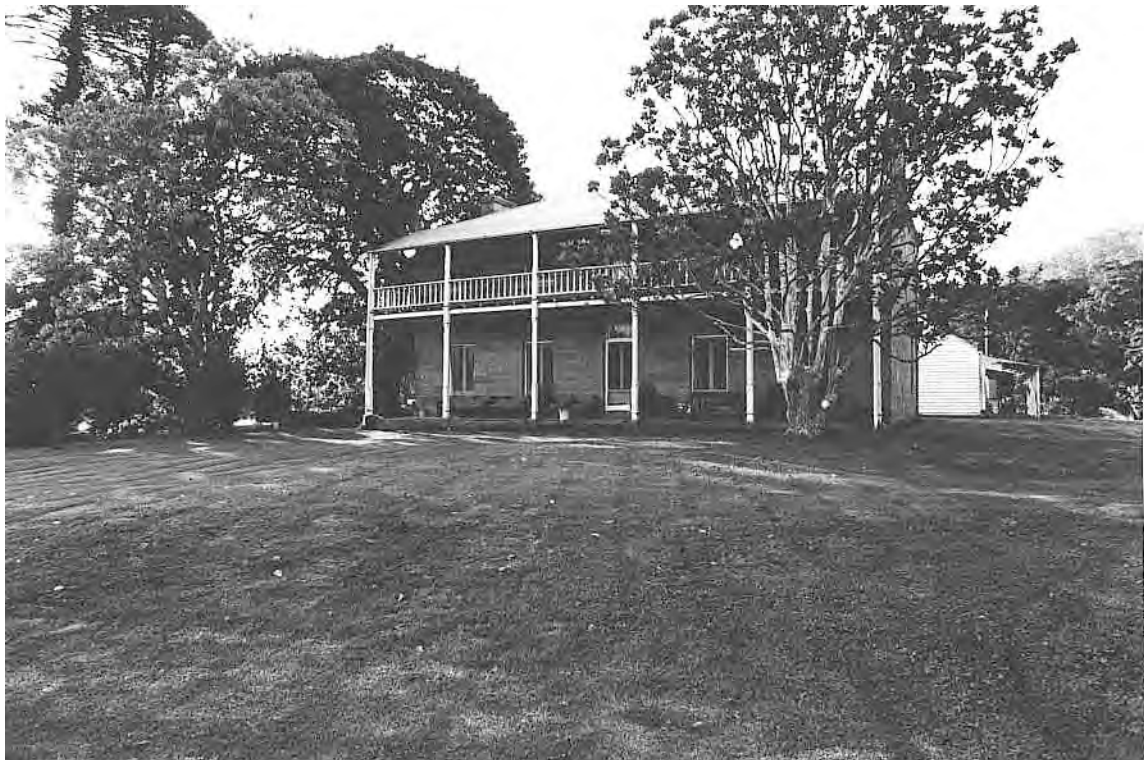
**BUNDANON  
CONSERVATION MANAGEMENT PLAN  
ILLUSTRATED CHRONOLOGY • FIGURE 75**

The tailored vista at the eastern front of the main house, ND but c1972  
Major plantings retained included the memorial jacaranda, the Bunya pines, the Moreton Bay fig and the magnolia tree.

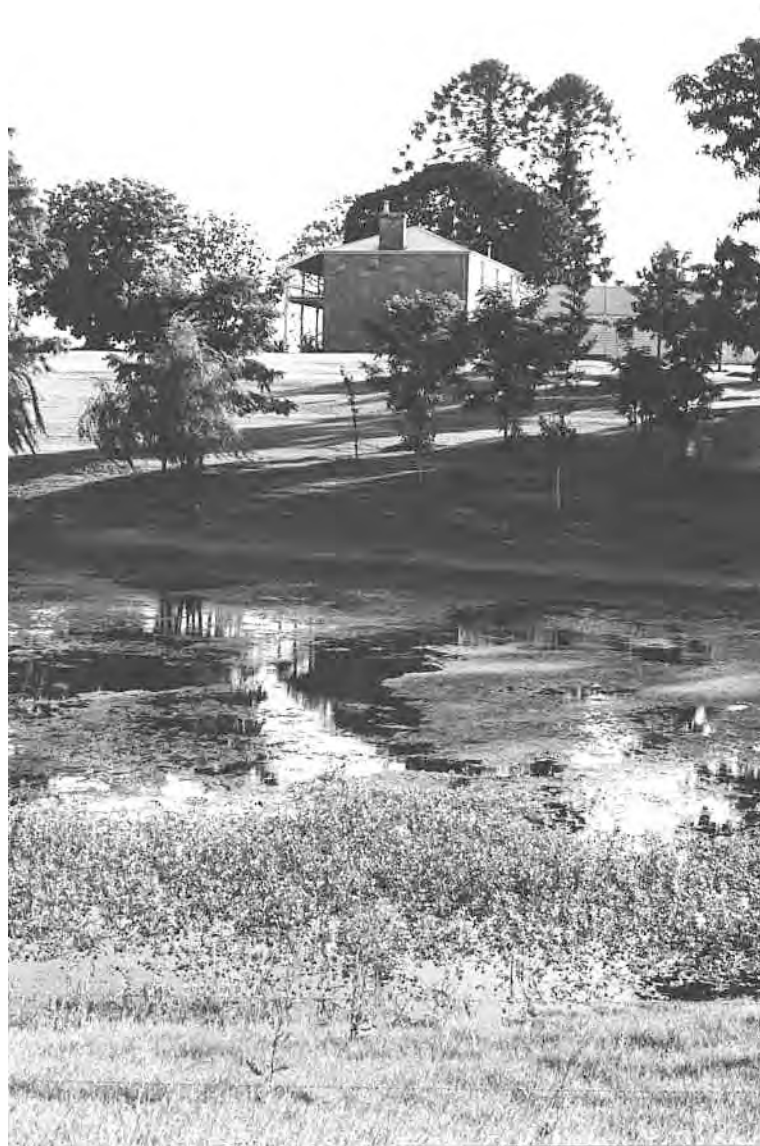
**BUNDANON  
CONSERVATION MANAGEMENT PLAN  
ILLUSTRATED CHRONOLOGY • FIGURE 76**

Bundanon house in its newly created landscape setting, ND but c1972.  
This view is taken from across the lagoon.

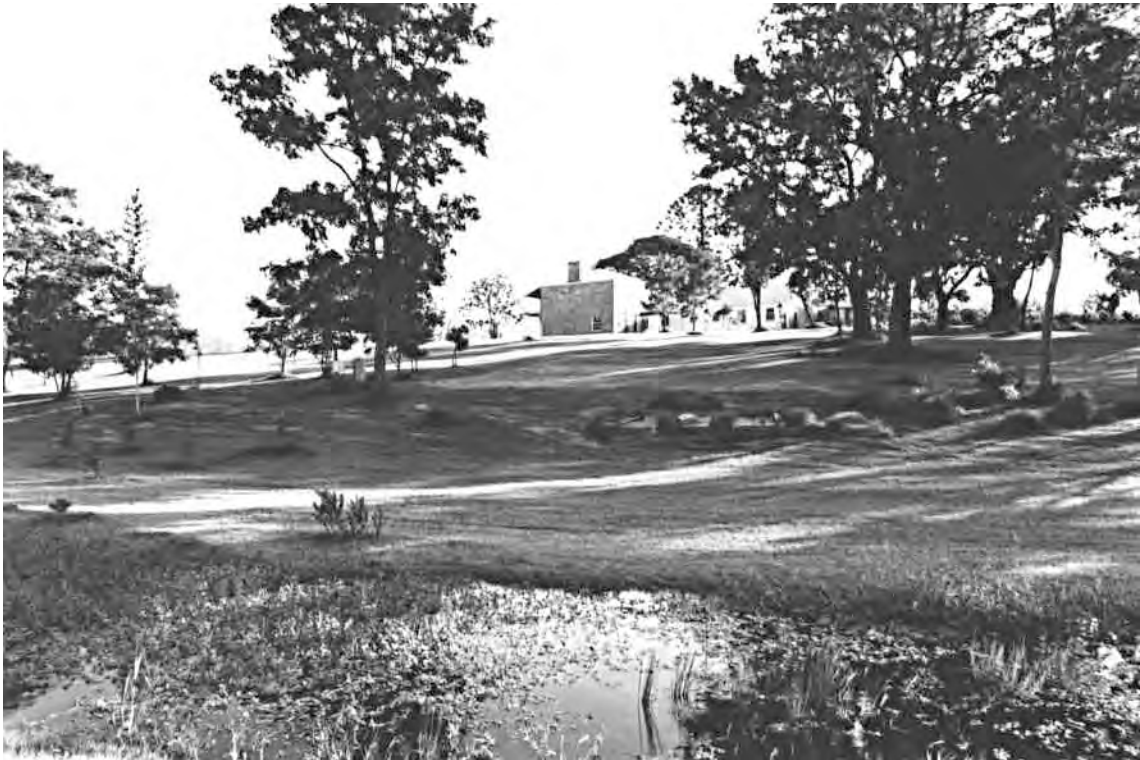
**BUNDANON  
CONSERVATION MANAGEMENT PLAN  
ILLUSTRATED CHRONOLOGY • FIGURE 77**

Bundanon house in its newly created landscape setting, ND but c1972.  
This view is taken from across the lagoon.
